# Manhole Inspection Summary

Manhole # S35II\_058MH

Insp Date: **3/14/07 8:46 AM**

**Location** Address: **326 FEDERAL ST**

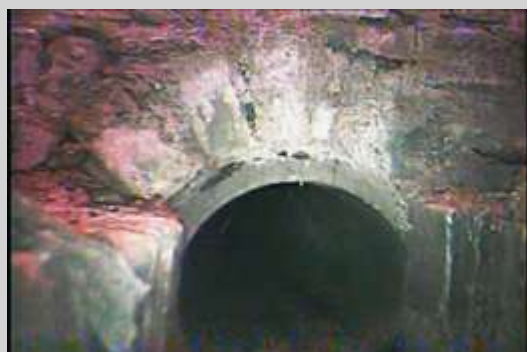
### 8 in. Circular Gravity Sewer

Pipe Out @ 12 O'Clock

Pipe Material: **Clay** ☐ Pipe Lined

Infiltration: **None** Pipe Seal Cond: **Unknown**
